FORT EGBERT AND EAGLE, ALASKA

❧ A PRESERVATION PLAN ❧

National Trust for Historic Preservation in the United States
740-748 Jackson Place, N.W.
Washington, D.C. 20006
Prepared Under Contract for the Bureau of Land Management

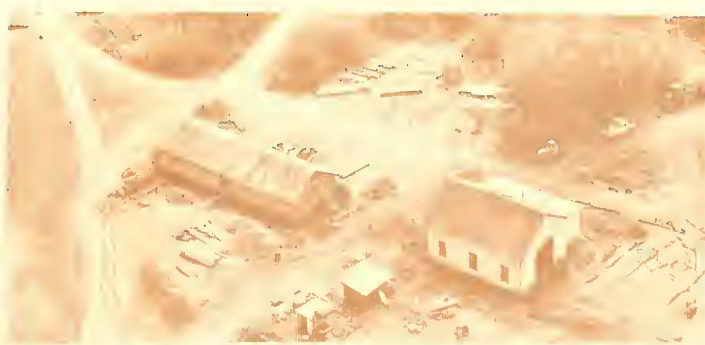
Figure 20. Stabilization of foundation of the Quartermaster storehouse (left) and the firehouse (water wagon shed). (Volz)

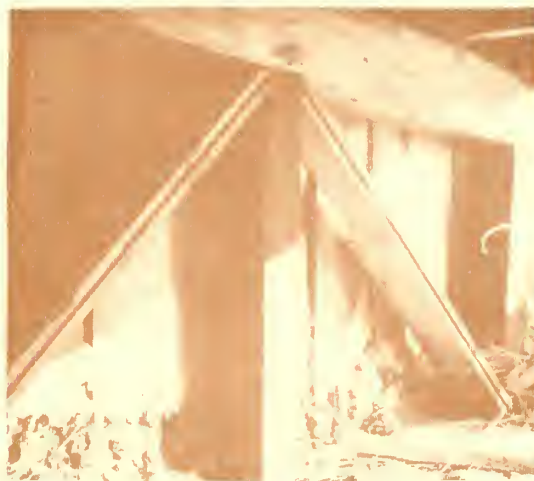
Figure 21. Deteriorated condition of siding on the granary due to direct contact with soil. Note that four to six inches of siding at ground level are totally decayed. (Volz)

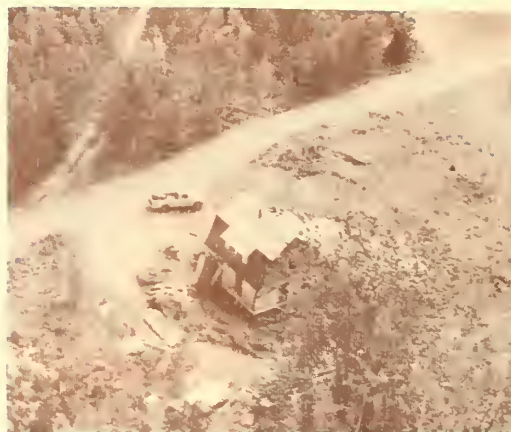
Figure 24. NCO quarters, July 1975, with foundation stabilization completed and building in process of being reroofed. Roofing and replacement of rear shed addition will take place in 1976. (Volz)

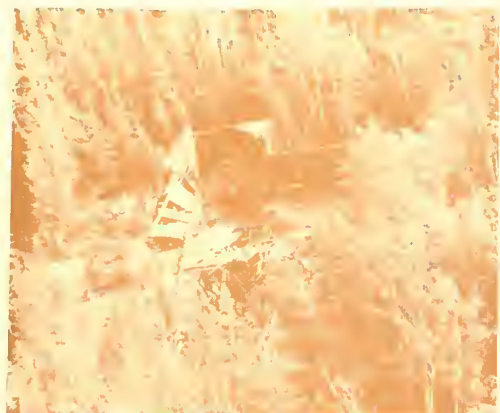
Figure 27. Ruins of second post hospital built in 1906. Remaining walls will be stabilized and potential hazards eliminated. (Volz)

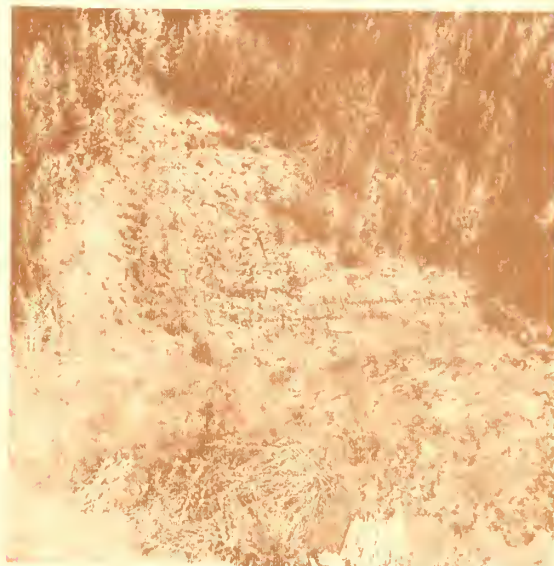
Figure 28. Ruins of enlisted men's barracks. Stringers and joists are still visible. Ruins will be stabilized and identified with interpretive markers. (Volz)

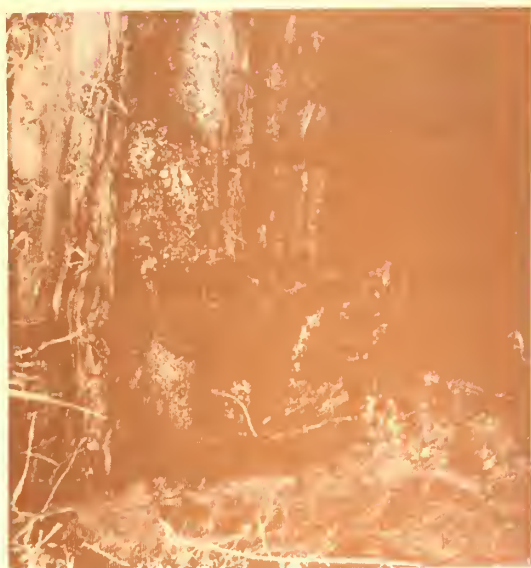
Figure 47. Supporting timbers of the courthouse were totally deteriorated and will require replacement during restoration. (Volz)
